CONTINUING ELIGIBILITY INSPECTION (CEI) REPORT  
FOR FLOOD CONTROL WORKS  
Honolulu Engineer District  
CEPOH-EC-T

1. Project Name: Kahawainui Stream Flood Control Project
2. Date of Inspection: November 9, 2007
3. Inspection Personnel:

4. Ratings for FY08  
Project Rating: **"MS, Marginally Satisfactory"**  
Project Condition Code: **"MA, Minimally Acceptable"**  
Project Status: **"Active"**

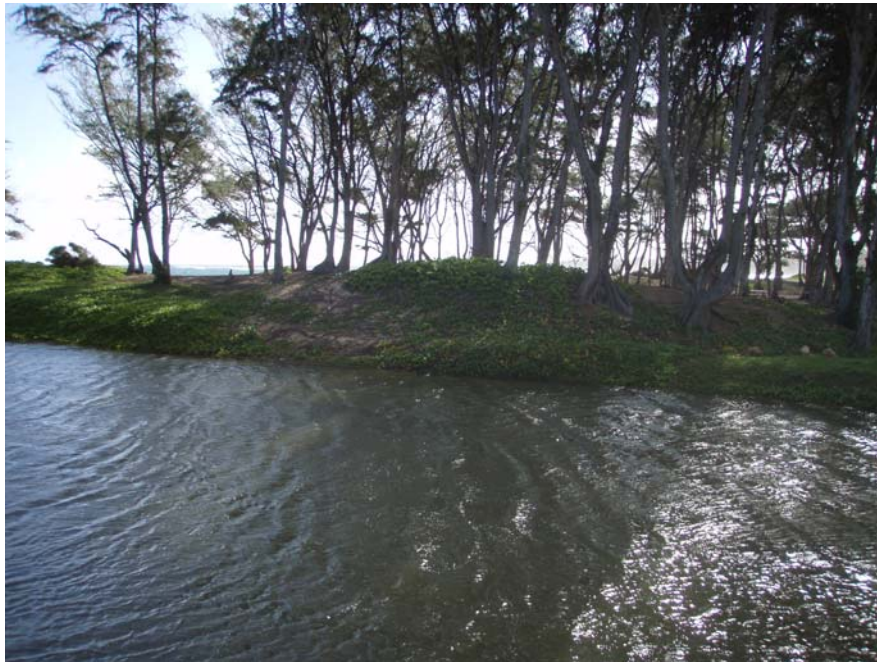
a. Sta. 14+00, RB in good condition.

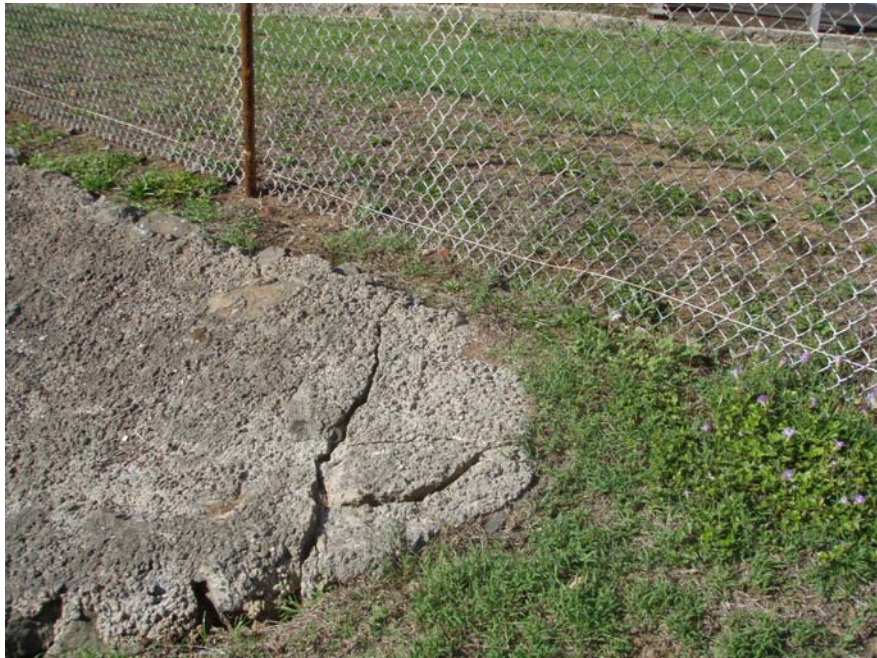
b. Sta. 41+50, LB, repair cracked concrete slope lining.

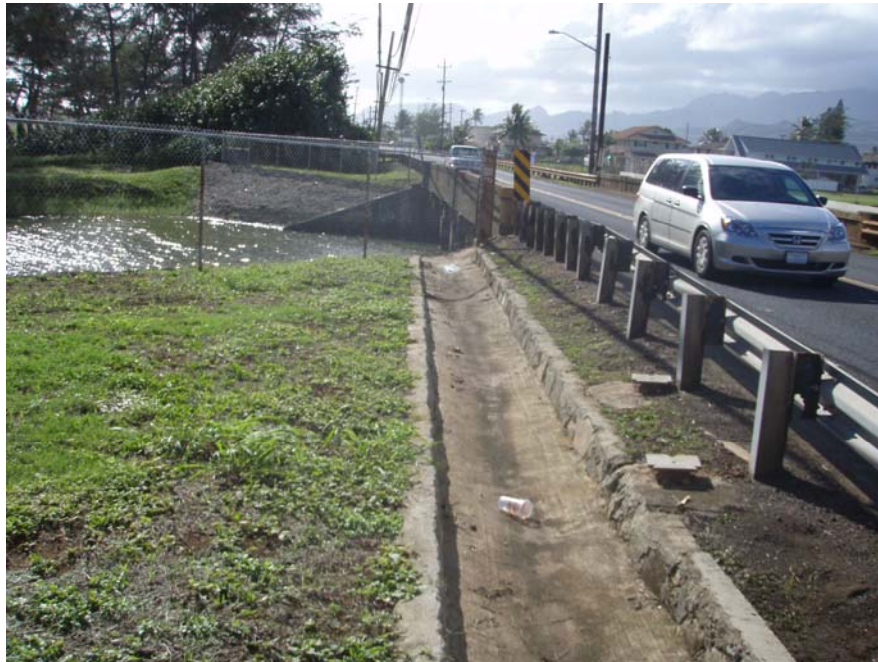
- c. Sta. 15+25, LB, a concrete lined swale has been constructed to correct the erosion problem.

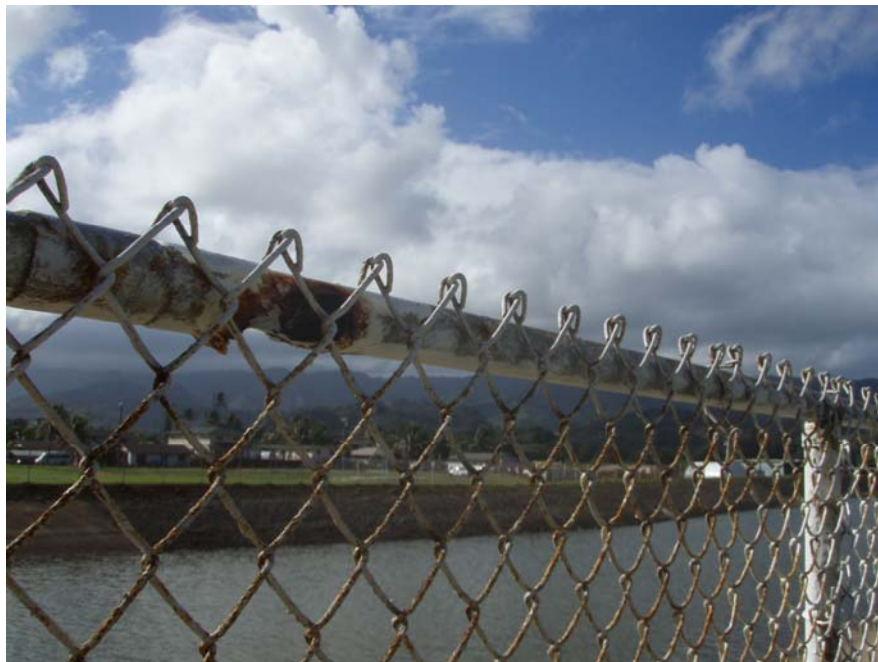
- d. LB, program to replace corroded fence.

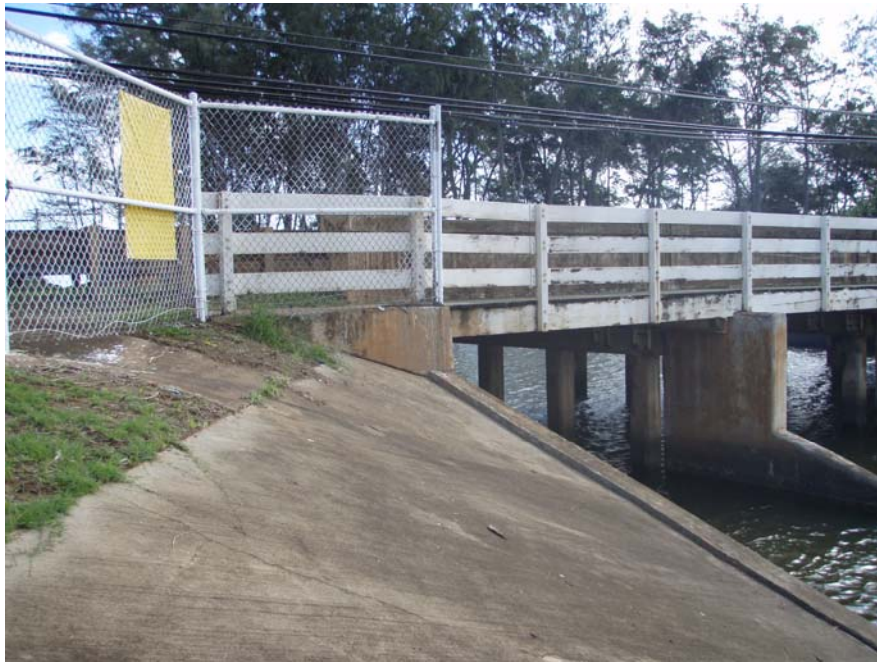
e. Sta. 16+00, (Centerline of Bridge), LB construction joint at headwall has been repaired, animal burrow hole has been filled.

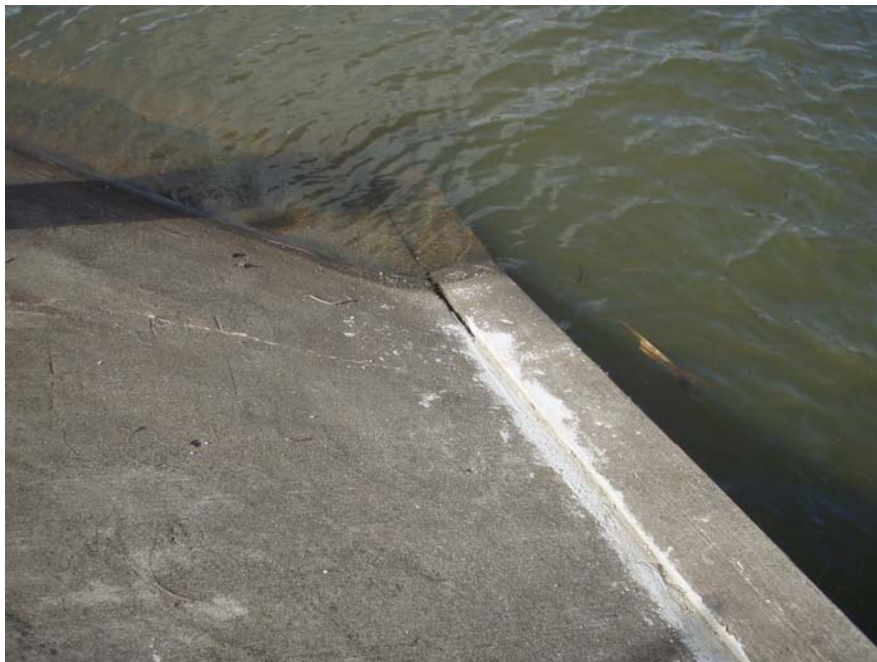
f. RB, Caulk the bottom portion of the construction joint.

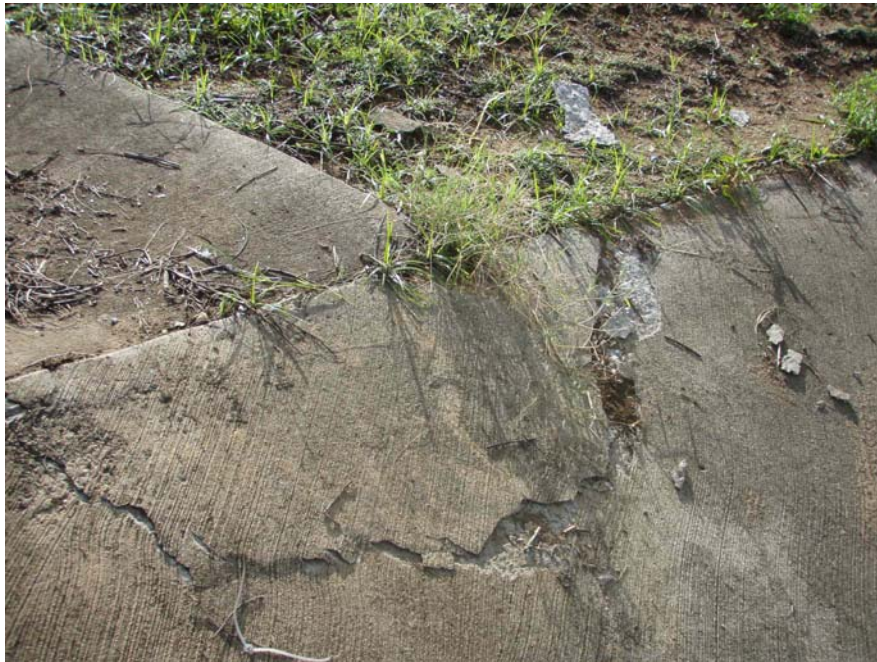
g. approx. Sta. 17+50, RB, patch cracked concrete.

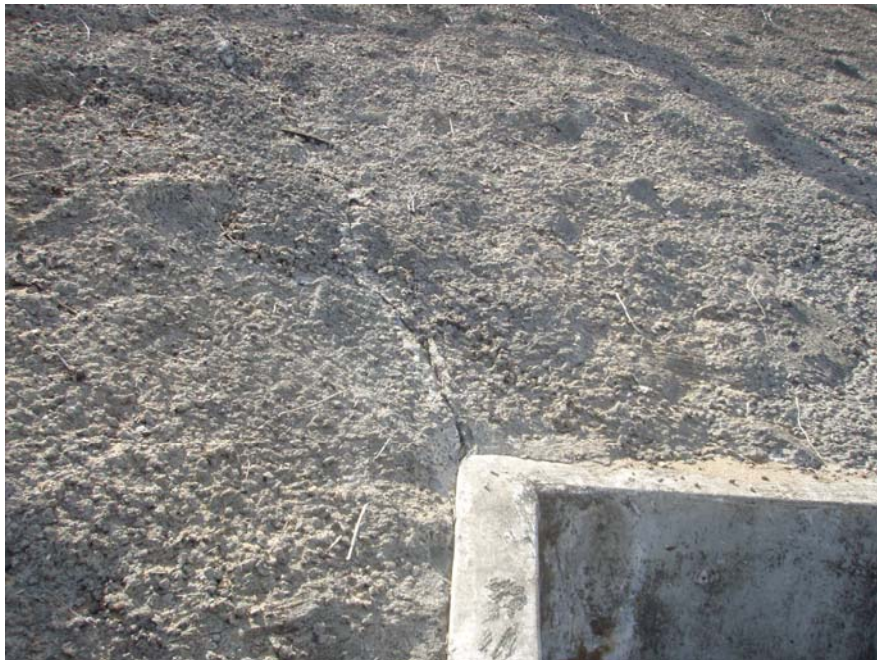
h. Sta. 19+50, RB, stream side, 36" culvert, lubricate flapgate and grout cracked boulder concrete lining.

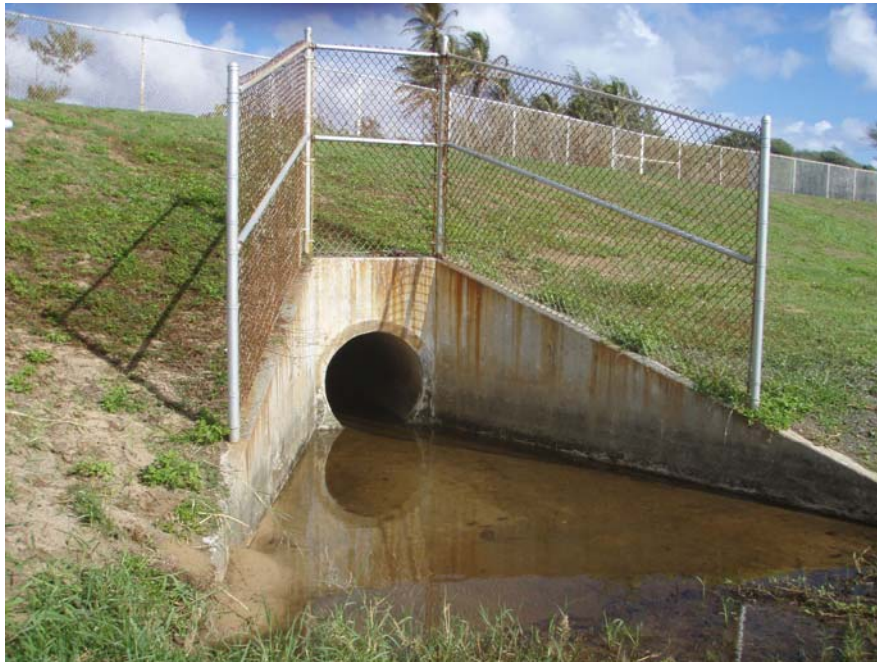
i. Sta. 19+50, RB, inland side, drain inlet in good condition.

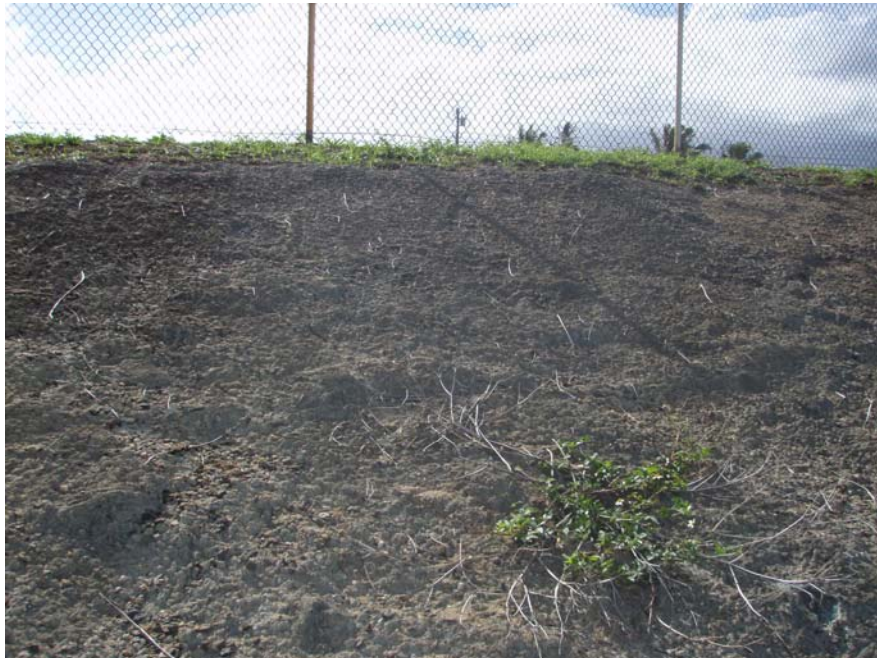
j. Sta. 20+50, RB, remove vegetation and grout crack in boulder concrete lining.

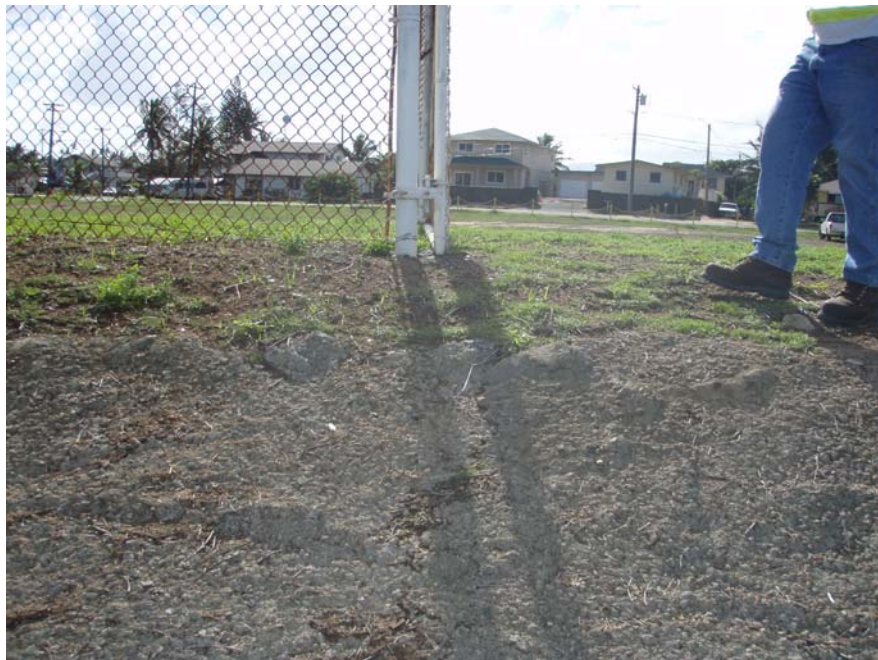
l. Sta. 21+00, RB, end of fence line, patch crack in concrete.

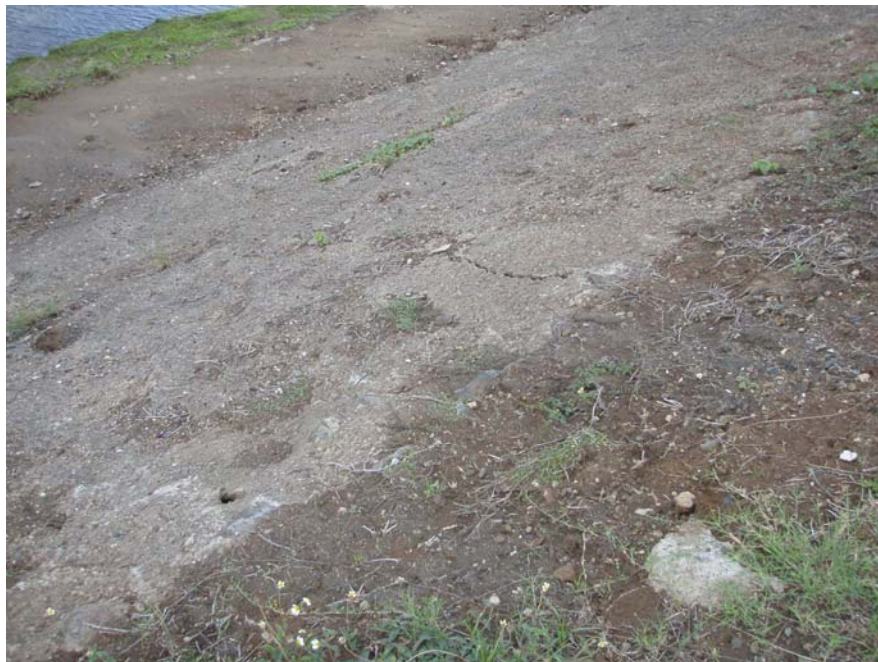
n. Sta. 2+00, RB, patch cracks in boulder concrete lining.

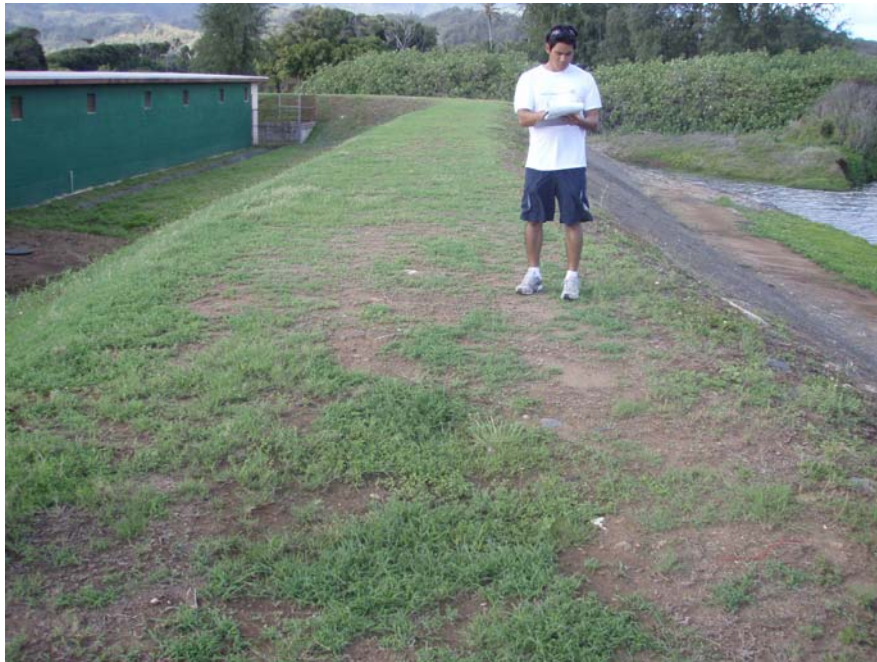
o. Sta. 4+00, RB, fill depression and restore levee crest elevation.

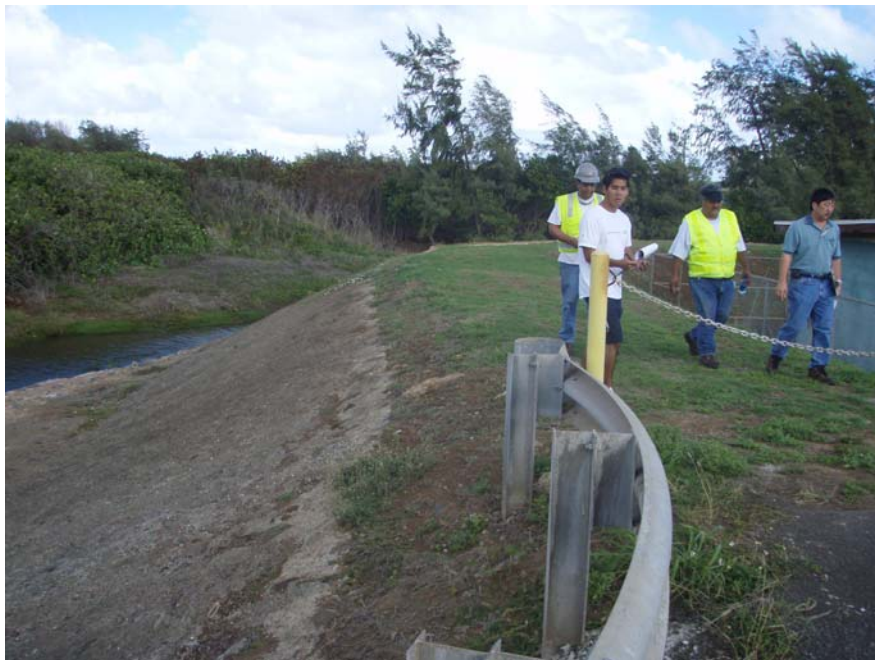
p. Sta. 6+62, RB, Overview, end of Levee A, good maintenance.

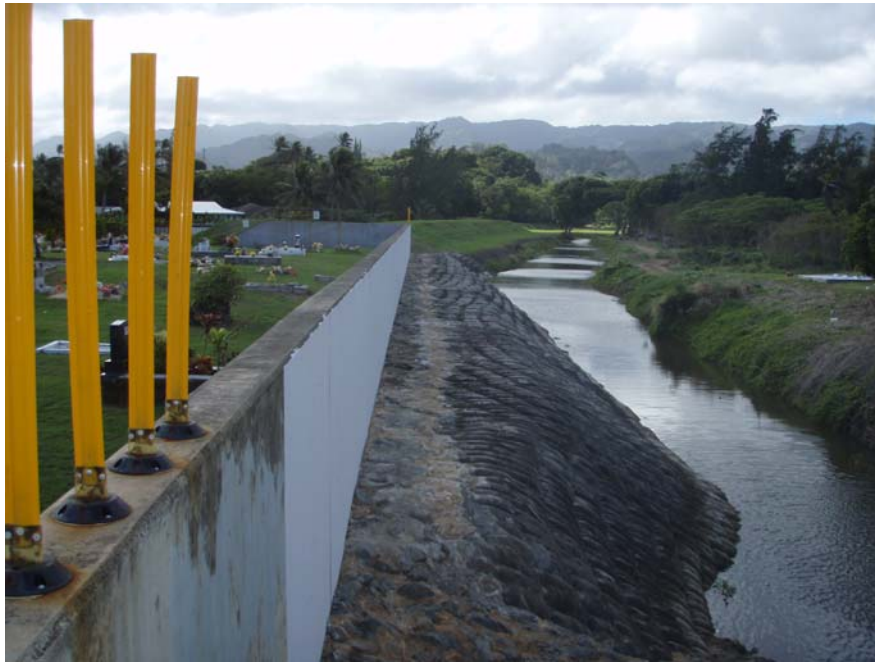
q. Sta. 4+73, RB, Concrete "I" Wall, good maintenance.

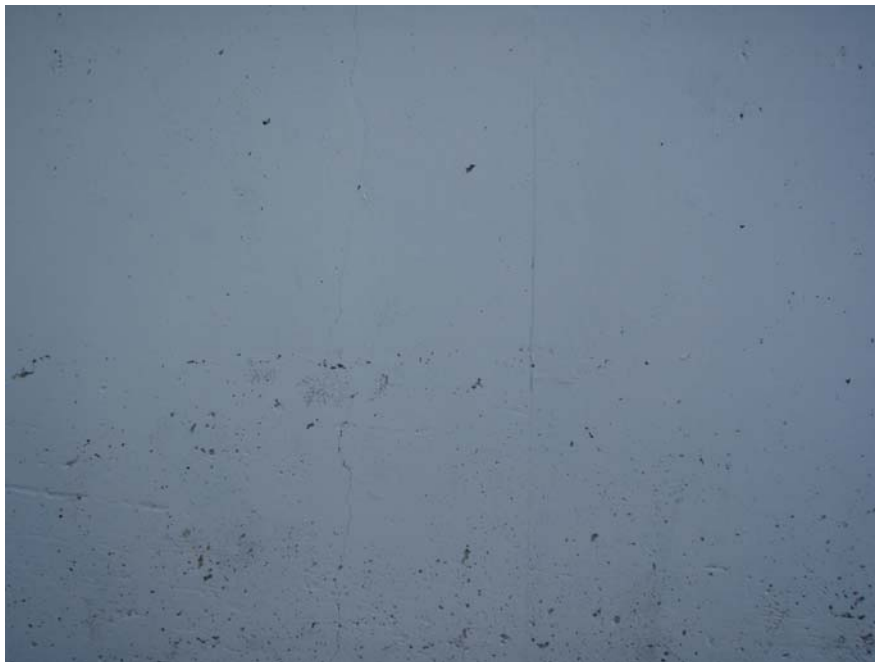
r. Sta. 3+00, RB, monitor crack in I-Wall.

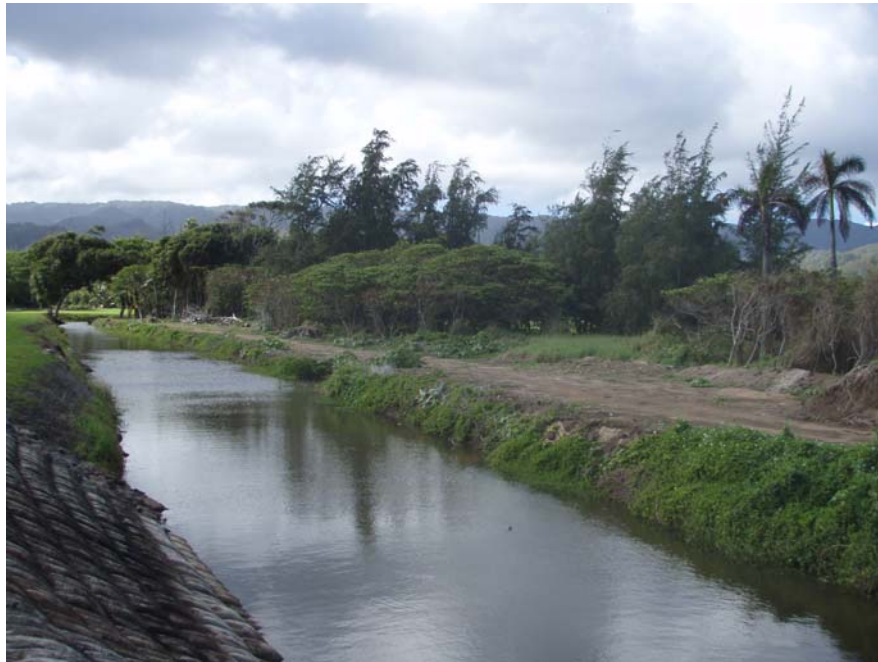
s. Sta. 3+50, RB, overview of stream, new maintenance road on LB.

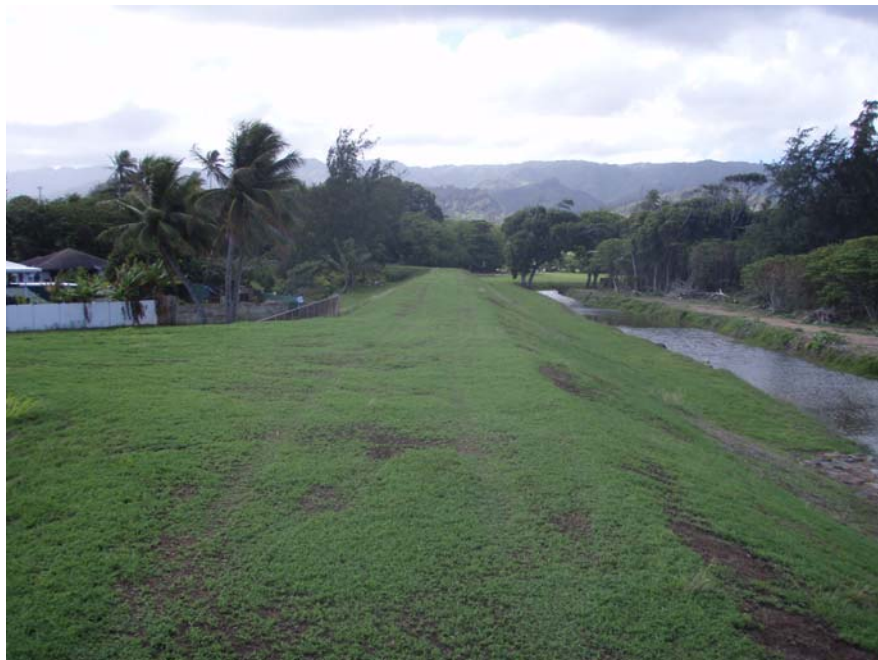
t. Sta. 4+73, RB, end of Concrete "I" Wall, beginning of Levee B, good maintenance.

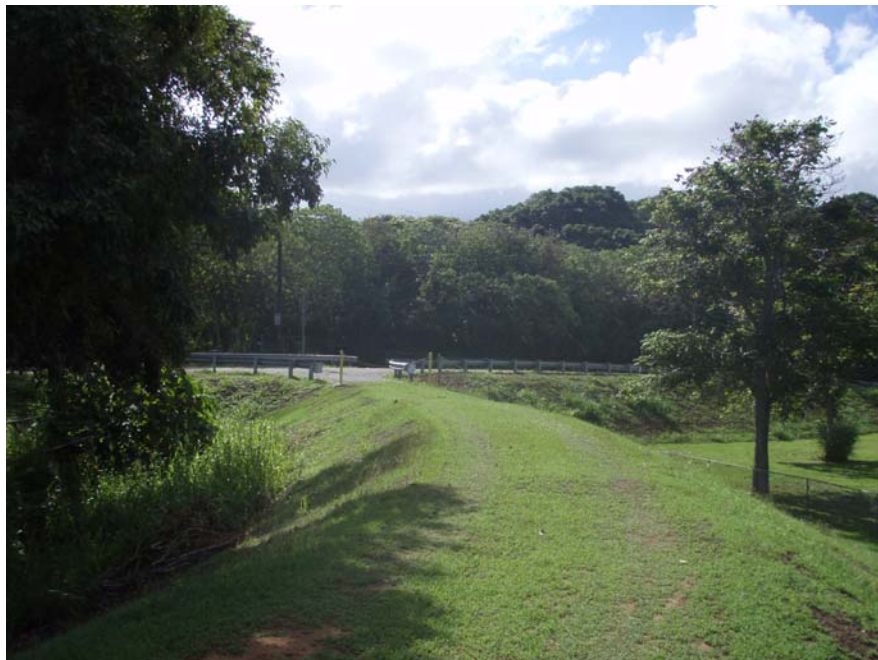
v. Sta. 6+57, RB, Levee B, overview, continue to maintain.

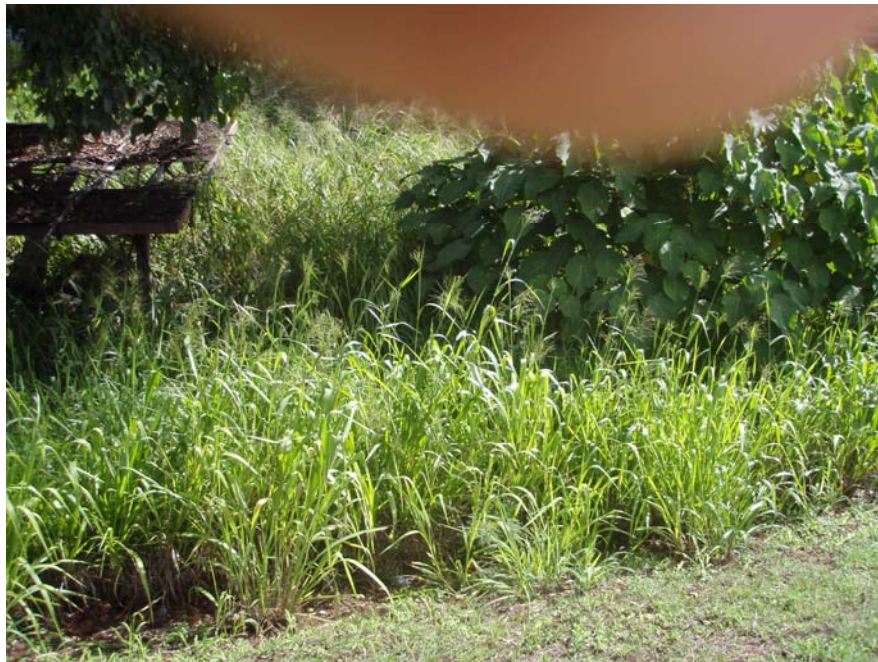
w. Sta. 7+00, RB, cut back vegetation on the inland side of the levee
